**Collision of Union Pacific Railroad Train
MHOTU-23 With BNSF Railway Company
Train MEAP-TUL-126-D With Subsequent
Derailment and Hazardous Materials Release
Macdona, Texas
June 28, 2004**

NTSB/RAR-06/03

**National
Transportation
Safety Board**

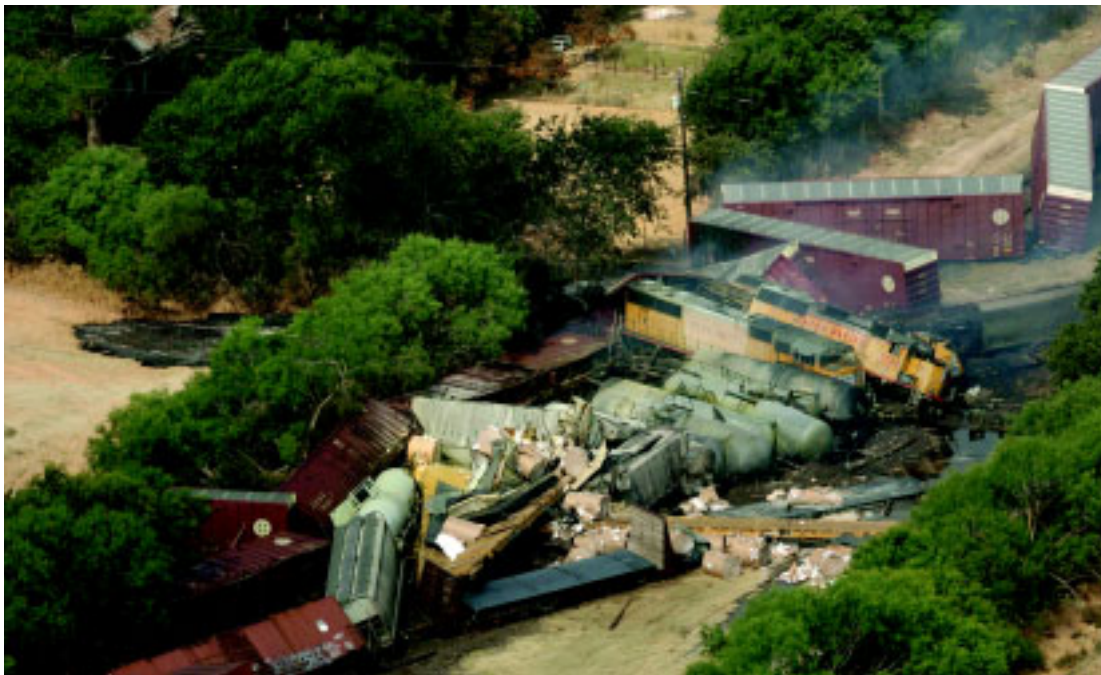
Figure 1. Post-derailment pileup.

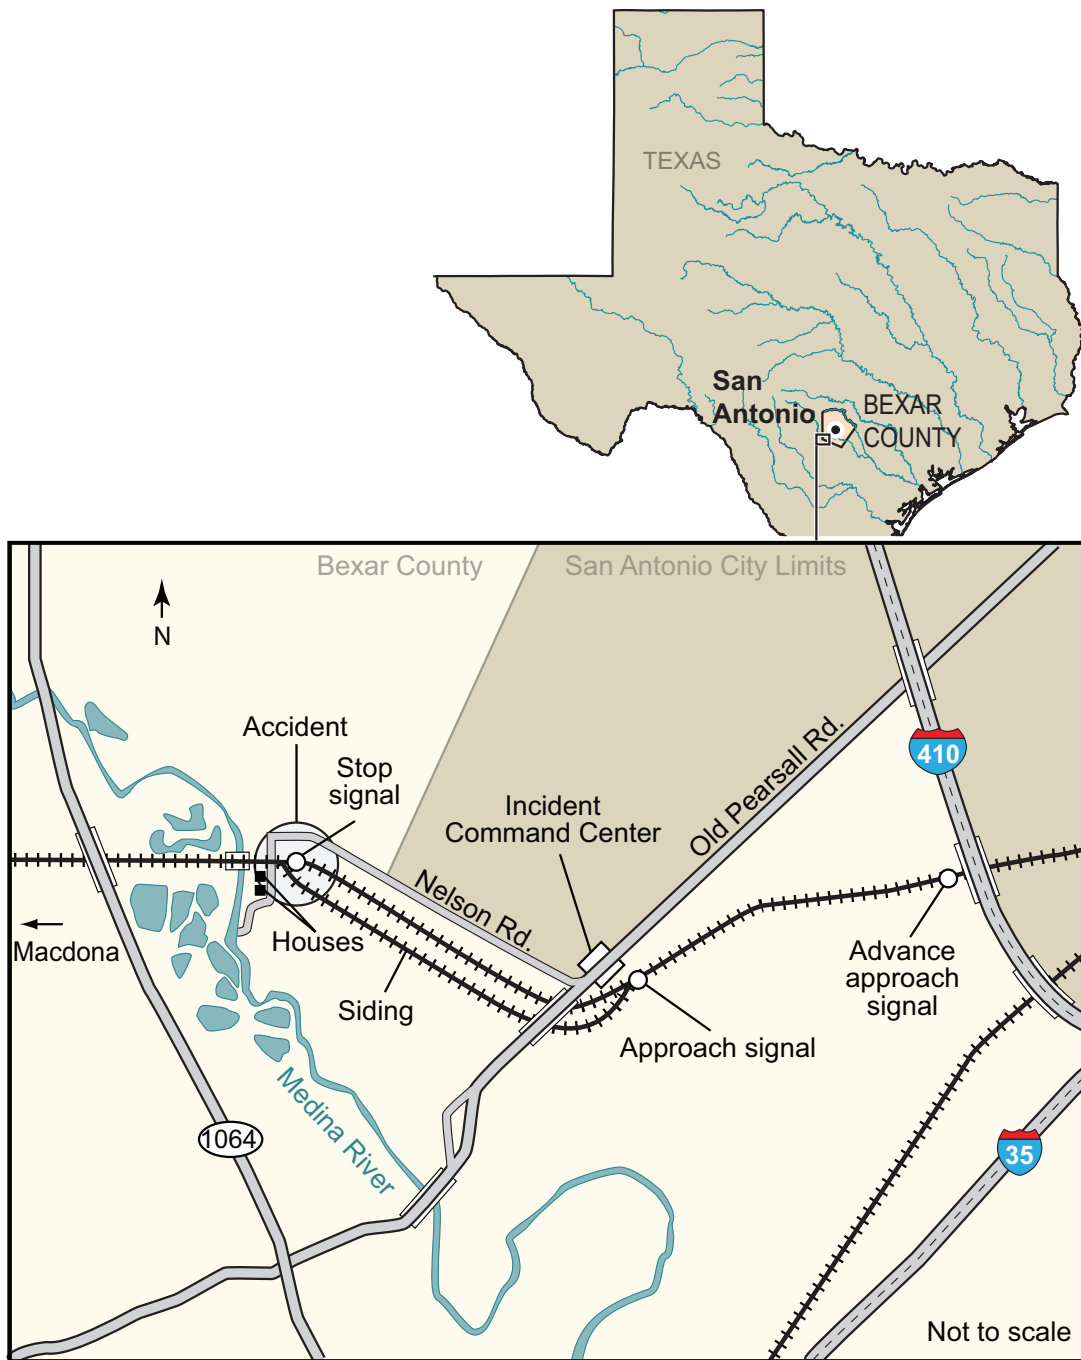
Figure 2. Portion of Union Pacific Railroad main line between San Antonio, Texas, and accident site at Macdona. Signals are identified with indications displayed for accident Union Pacific Railroad train.

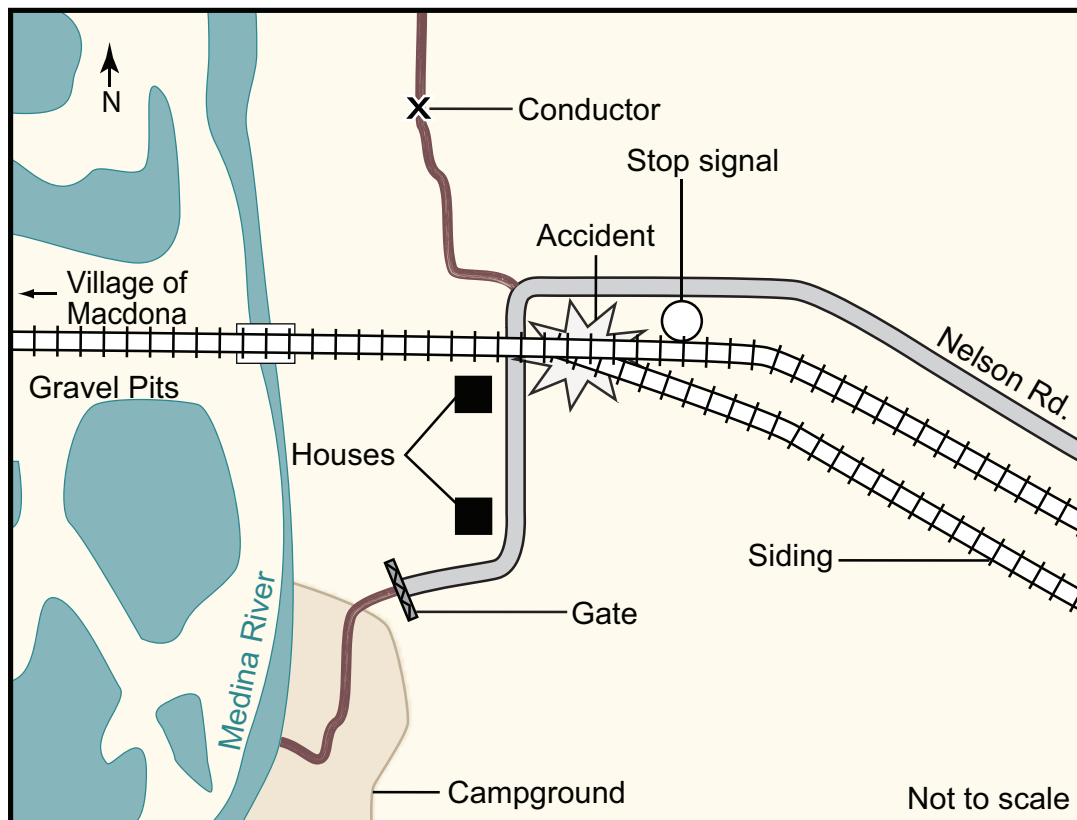
Event recorder data showed that between 5:03:17 and 5:03:19, the UP train's emergency braking automatically activated, and the train's recorded speed dropped from 44 mph to 0. The investigation later determined that the UP train had passed the *stop* signal at the west end of the Macdona siding, struck the 63rd car of the BNSF train, and derailed near the west siding switch. (See figure 3.)

Figure 3. Accident site showing point of collision, driveway leading off Nelson Road where conductor was found, and houses where residents were trapped by gas cloud.

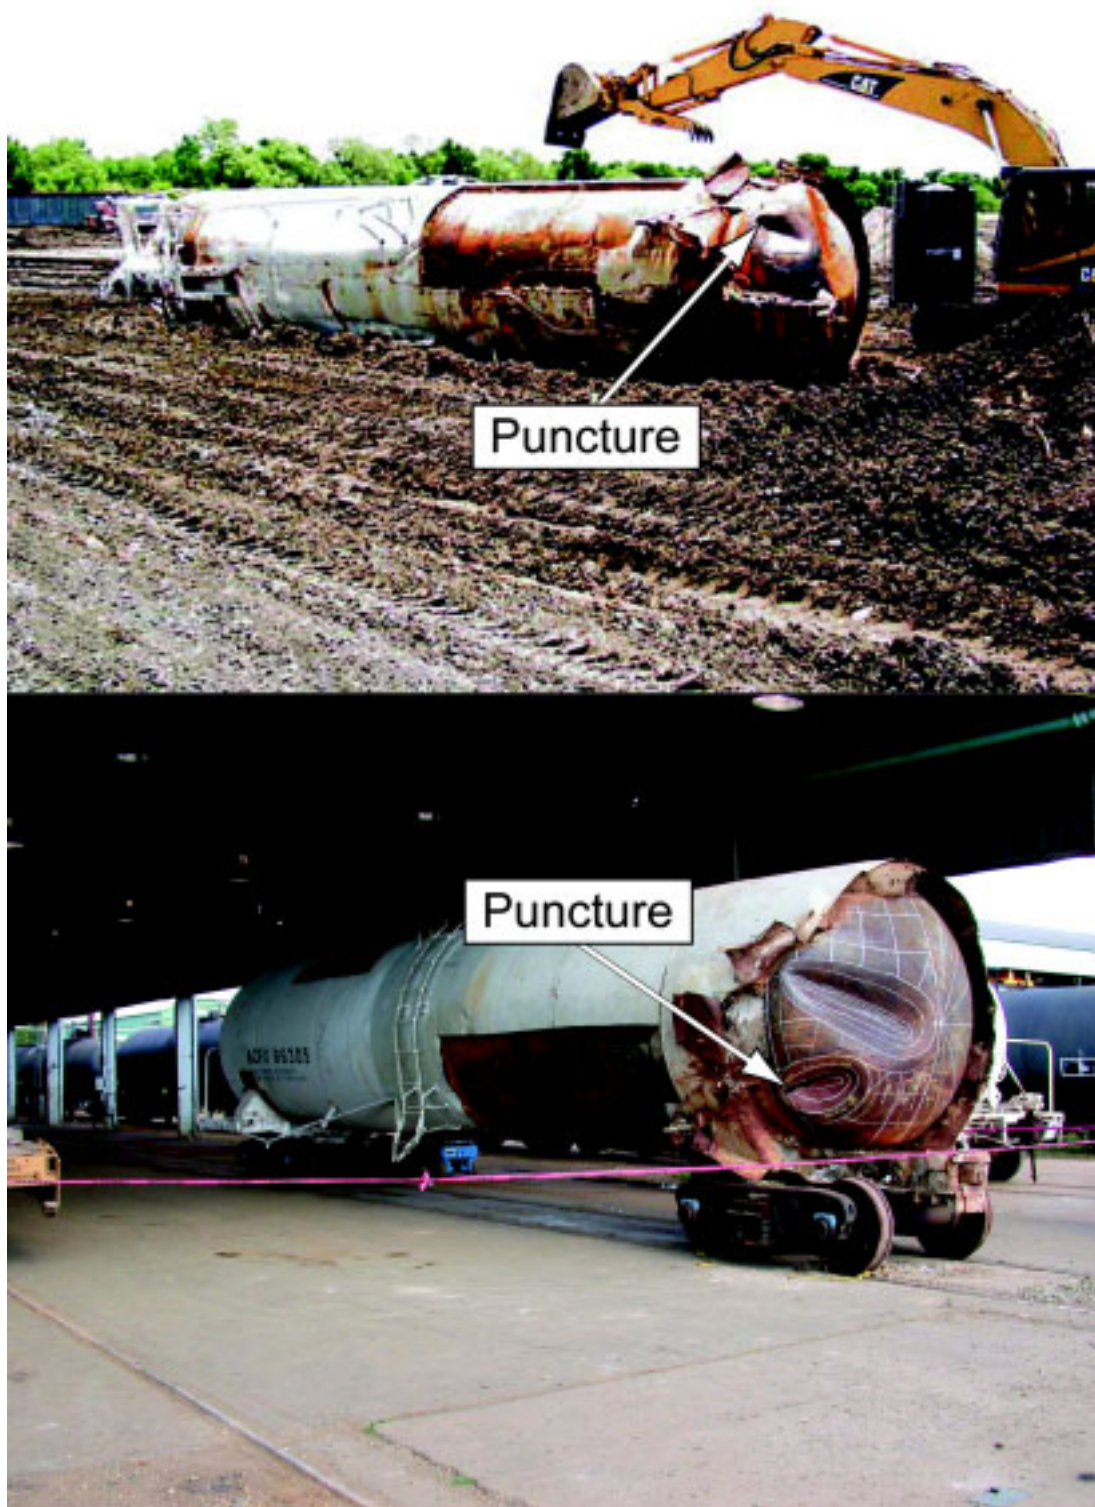
The right corner of the A-end had sustained two dents. One was a 4-inch-deep dent in the lower quadrant of the head (the curved end) of the tank. This dent contained a 2-inch by 11-inch puncture, which terminated 1 inch beyond the seam joining the tank head to the tank shell. The response team had plugged the puncture with wooden wedges during the initial response. The second dent had overall dimensions of 34 inches by 58 inches. This dent contained a rectangular impression measuring approximately 2 inches by 58 inches. There was no evidence of additional damage to the remainder of the tank head, shell, or pressure-retaining components of the car. (See figure 4.)

Figure 4. Punctured chlorine tank car at accident site (top) and after recovery (bottom).

The portion of the breached tank that contained the puncture and dent was cut from the car for examination. When this excised head portion was placed against the deformed corner of the flatcar with the foam residue, the fold on the top surface of the flatcar fit snugly into the punctured portion of the head. The size of the puncture and inward deformation on the head were consistent with the shape and size of the damaged corner of the flatcar.

The thicknesses of the head and shell of the tank of the punctured tank car were measured at the Safety Board's Materials Laboratory. The thickness of the tank head in areas with no deformation damage measured between 0.813 and 0.830 inch, confirming that the thickness of the head was greater than the nominal thickness specified in the certificate of construction (0.8125 inch). The thickness of the wall at the fracture in the area that exhibited the most severe deformation measured approximately 0.5 inch. The deformation had

Although the details of the fracture surface of the puncture were obliterated by exposure to chlorine and water, many portions of the fracture were on a slant plane, and the tank was severely deformed in the vicinity of the puncture. Such features are consistent with ductile failure. To gain more information about the fracture toughness and resistance to fracture of the tank head and tank shell, the Safety Board arranged to conduct Charpy tests on coupons from those areas.²⁵ The results of the Charpy tests indicated that the hot-formed tank head had properties similar to normalized steel,²⁶ with a ductile-to-brittle transition temperature of -40° F. The tests revealed that the steel in the tank shell had a ductile-to-brittle transition temperature greater than 85° F.²⁷ At 32° F (close to the loading temperature of the chlorine in the tank car), the energy absorbed by tank shell Charpy specimens oriented transversely to the rolling direction of the steel plate (the orientation with minimum fracture toughness) averaged 13 foot-pounds.
